### Historic barrel vaults undergoing differential settlements

D'Altri, AM, De Miranda, S, Castellazzi, G, Sarhosis, V, Hudson, J & Theodossopoulos, D 2019, 'Historic barrel vaults undergoing differential settlements', *International Journal of Architectural Heritage: Conservation, Analysis and Restoration (International Journal of Architectural Heritage)*, vol. 14, no. 8, pp. 1-14. <https://doi.org/10.1080/15583058.2019.1596332>

# Historic barrel vaults undergoing differential settlements

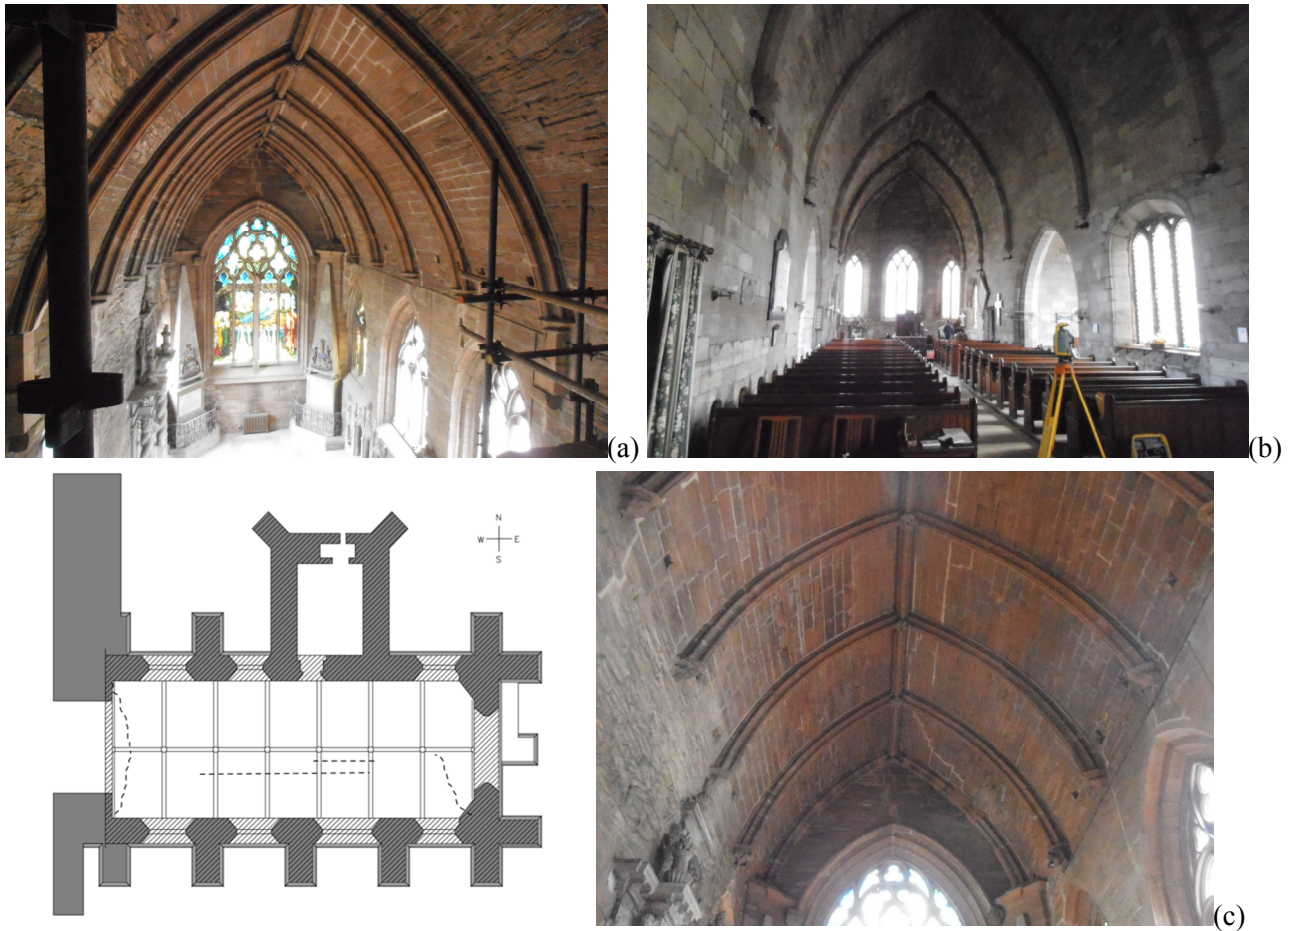
Fig. 1 – The earliest (a) (Bothwell 1398) and latest (b) (Ladykirk 1500) examples of barrel vaults in late-medieval Scotland churches. Crack pattern in Bothwell (c) due to deformation in the South wall from [27] and its appearance at the East end of the interior (following repairs in 2016), (settlement caused at the right-hand corner).

Considering the construction evolution since the earliest (1398) to the latest (1500) examples, we can observe that pier buttresses contain the thrust and become thicker and safer towards the end of the period (e.g. Ladykirk, Fig. 1b). Construction also improves in its visual expression, using polished ashlar (Crichton in 1449, Seton in 1478). Measured surveys [29] have shown precision in the execution of the form and very little deformation. This was not the case of the Bothwell church though (Fig. 1a), which has suffered differential settlement on its South side (Fig. 1c), as the foundations had slipped outwards and the clay under the south-east corner had settled significantly, and had to undergo repair and bracing (2014-16). The horizontal spread component of this vault was examined first [30] in an experimental and analytical programme of a homogeneous model and then the vertical settlement only in a masonry-replica model [27], showing the vulnerability of the scheme to such instability. The two damage patterns were quite similar as well, which makes repair to a certain extent easier to plan.
